**Flood Control Project Maintenance
Levee Inspections**

Fall 2016 Levee Maintenance Deficiency Summary Report

Reclamation District No. 1660 Tisdale

Levee Inspection Report By Mile - Fall 2016

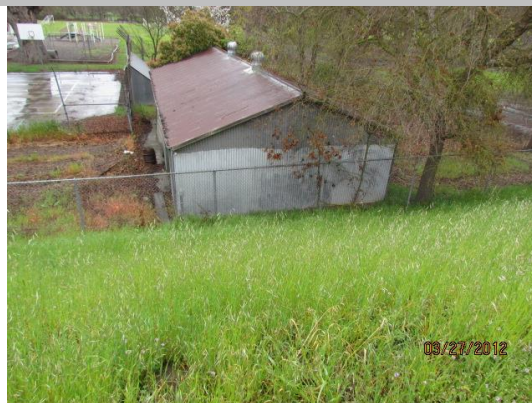
Photo 1 of 1 : FA_2016_RD1660_8_12_20160823_00005.jpg

LM Start	0.05	Rating **	M	Issue No.	12
LM End	0.05	Issue Type +	En	Location *	LS
Category	Earthen Levee			GPS Latitude/Longitude	
				Start	End
Item	Encroachments			39.062643 °	39.062643 °
				-121.837857 °	-121.837857 °
DWR ID	DWR_RD1660_01_s_2012_12				
Comment Code					
BU : Building					
Inspector Comment

View of the building and fence at the landside toe.

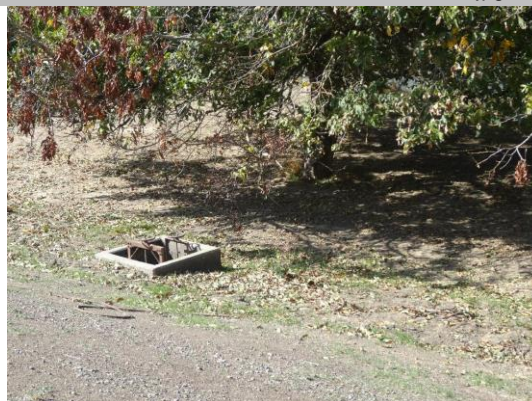
Photo 1 of 2 : UCIP_FA_2016_46670_38107.jpg

LM Start	0.14	Rating **	M	Issue No.	22
LM End	0.14	Issue Type +	En	Location *	LS
Category	Supplemental			GPS Latitude/Longitude	
				Start	End
Item	DWR UCIP Field Study			39.061322 °	39.061322 °
				-121.837993 °	-121.837993 °
DWR ID					
Comment Code					
Inspector Comment					
FS_ID:46670 DS_ID:22489 EP_NO: N/A Repair Type: Non-Urgent Crossing Status: Found UCIP Comments: - needs proper abandonment.- opening of landside pipe almost burried. FIELD_STRUCT_DESC: *ABANDONED* 24-inch pipe thru levee, 16.4 FBC. Slide gate in concrete well at toe of WW slope. (IV A-Winship). USACE bench mark on top of headwall at LS toe. O&M Manual SAC 133, August 1955. FS Date: 10/10/2013

WS view: concrete box on levee slope. No pipe found on berm and river bank.

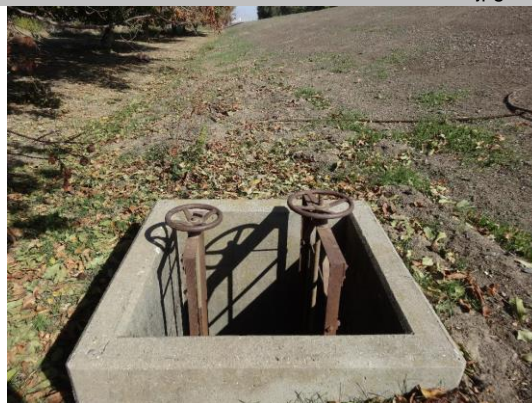
Photo 2 of 2 : UCIP_FA_2016_46670_38106.jpg

WS view: two slide gates in concrete box on levee slope.

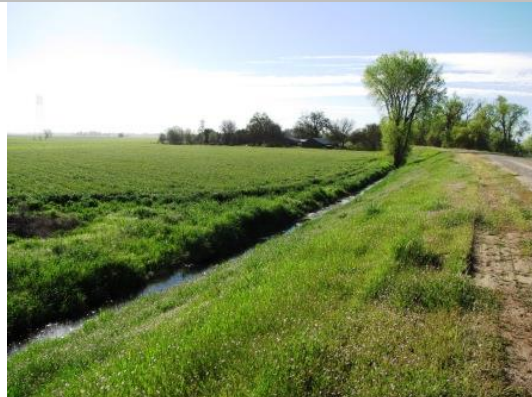
Photo 1 of 1 : FA_2016_RD1660_8_9_20160823_00004.jpg

LM Start	1.10	Rating **	M	Issue No.	9
LM End	1.45	Issue Type +	En	Location *	LS
Category	Earthen Levee			GPS Latitude/Longitude	
				Start	End
Item	Encroachments			39.047610 °	39.043221 °
				-121.838802 °	-121.835815 °
DWR ID	DWR_RD1660_01_s_2012_9				
Comment Code					
DT : Ditch					
Inspector Comment

View of a ditch along the landside toe.

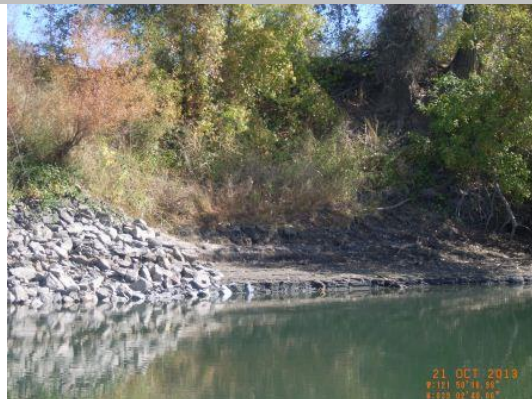
Photo 1 of 1 : FA_2016_RD1660_8_8_20160823_00003.jpg

LM Start	1.33	Rating **	M	Issue No.	8
LM End	1.36	Issue Type +	Ma	Location *	WS
Category	Supplemental			GPS Latitude/Longitude	
				Start	End
Item	2015 USACE Erosion Survey, DRAFT			39.044361 °	39.043916 °
				-121.837654 °	-121.837305 °
DWR ID	DWR_RD1660_01_s_2016_8				
Comment Code					
Inspector Comment					
2009 - Erosion on levee toe where an old cobble site is failing. 2011 - Some new minor erosion. 2012 - Site extended downstream, bank is being impacted from the weight of the trees. 2013 - Minor new erosion at the toe. 2015: Minor new erosion at the toe. [2015 Site ID: SAC_120-6_L]

USACE 2013 Photo #1

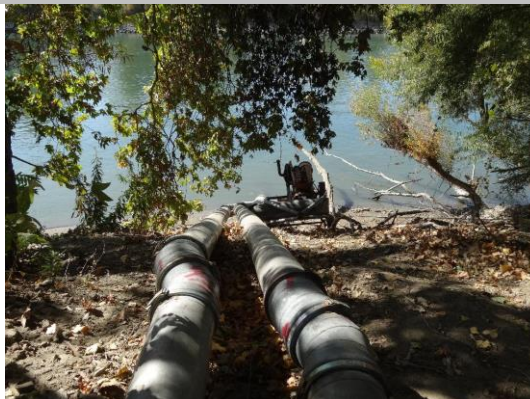
Photo 1 of 2 : UCIP_FA_2016_22543_38142.jpg

Comment Code					
Inspector Comment					
FS_ID:22543 DS_ID:22484 EP_NO: 16476 Repair Type: Non-Urgent Crossing Status: Found UCIP Comments: - 16-inch old steel pipe abandoned. Abandoned pipe found on landside levee toe.- abandoned power pole on waterside.- mobile diesel pump on channel bank.- attached tin pipes exposed on levee surface. FIELD_STRUCT_DESC: 14-inch steel pipe through the levee crown, the placement of two 12-inch diameter tin pipes on the surface of the levee slopes attached to the existing 14-inch steel pipe. The pipe discharges into irrigation ditch on landside. An air vent on landside shoulder. (App. No. 16476 - Ettl, 1997). FS Date: 10/10/2013

WS view: two exposed 12" tin pipes on levee slope. These pipes connected to the pump on river bank.

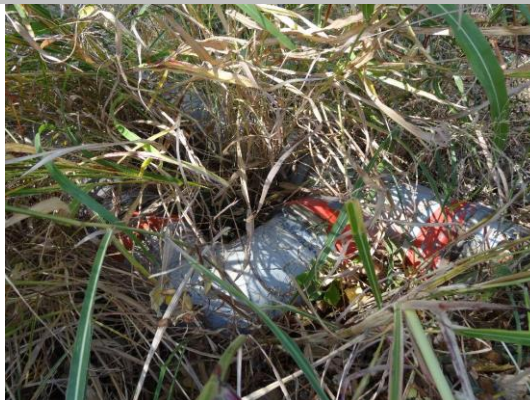
Photo 2 of 2 : UCIP_FA_2016_22543_38141.jpg

WS view: two exposed 12" tin pipes on levee slope.

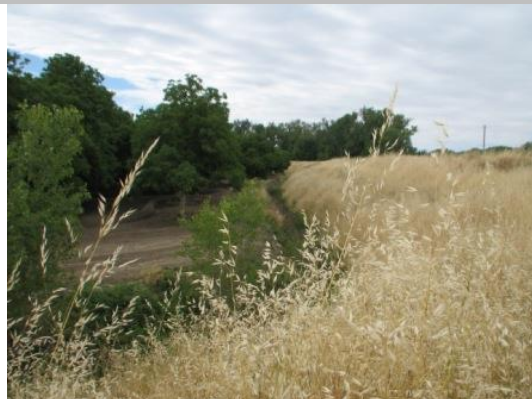
Photo 1 of 1 : FA_2016_RD1660_8_1_20160823_00001.jpg

LM Start	2.01	Rating **	U	Issue No.	1
LM End	2.34	Issue Type +	En	Location *	LS
Category	Earthen Levee			GPS Latitude/Longitude	
				Start	End
Item	Encroachments			39.037640 °	39.034416 °
				-121.828421 °	-121.825698 °
DWR ID	DWR_RD1660_01_s_2012_1				
Comment Code					
DT : Ditch					
Inspector Comment

View of a large ditch along the landside toe.

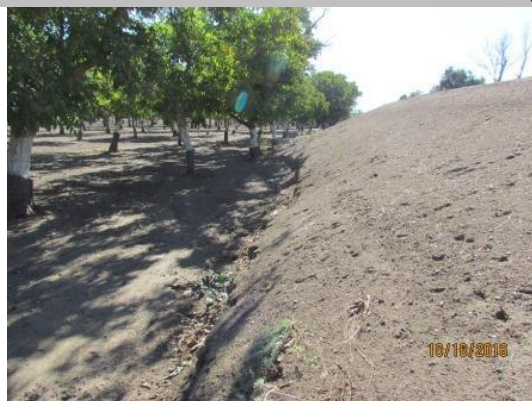
Photo 1 of 1 : FA_2016_RD1660_8_2_20161028_00016.jpg

LM Start	2.37	Rating **	M	Issue No.	2
LM End	2.37	Issue Type +	Ma	Location *	LS
Category	Earthen Levee			GPS Latitude/Longitude	
				Start	End
Item	Slope Stability			39.034107 °	39.034107 °
				-121.825152 °	-121.825152 °
DWR ID	DWR_RD1660_01_s_2012_2				
Comment Code					
S1 : Repair slope instability.					
Inspector Comment

View of the toe cut by the farmer on the landside.

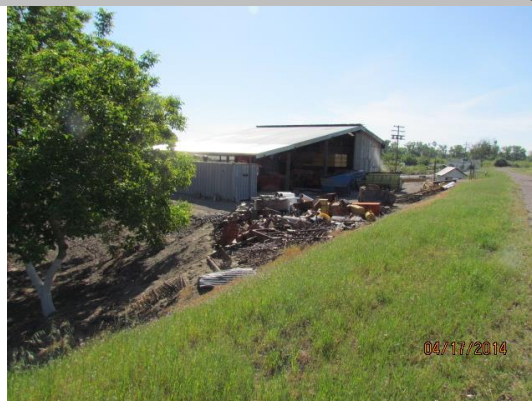
Photo 1 of 1 : FA_2016_RD1660_8_3_20160823_00002.jpg

LM Start	2.58	Rating **	M	Issue No.	3
LM End	2.58	Issue Type +	En	Location *	LS
Category	Earthen Levee			GPS Latitude/Longitude	
				Start	End
Item	Encroachments			39.031405 °	39.031405 °
				-121.823403 °	-121.823403 °
DWR ID	DWR_RD1660_01_s_2012_3				
Comment Code					
EQ : Equipment					
Inspector Comment

View of equipment along the landside slope.

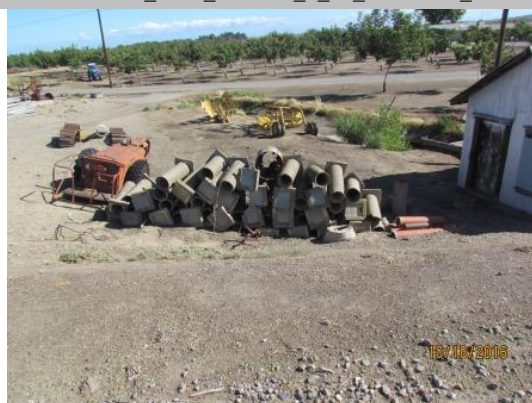
Photo 1 of 1 : FA_2016_RD1660_8_18_20161028_00017.jpg

LM Start	2.61	Rating **	M	Issue No.	18
LM End	2.61	Issue Type +	En	Location *	LS
Category	Earthen Levee			GPS Latitude/Longitude	
				Start	End
Item	Encroachments			39.031020 °	39.031020 °
				-121.823091 °	-121.823091 °
DWR ID	DWR_RD1660_01_f_2016_18				
Comment Code					
DE : Debris					
Inspector Comment					
Remove concrete pipes from the landside toe.

View of the concrete pipes within the levee easement.

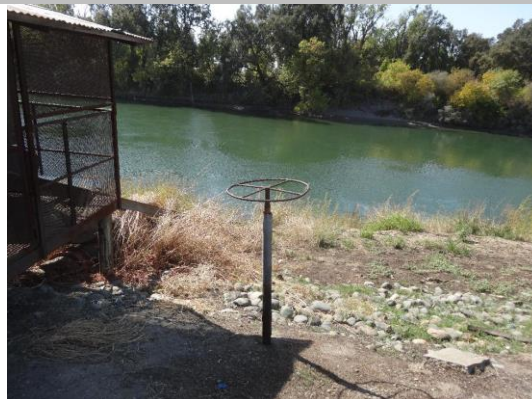
Photo 1 of 2 : UCIP_FA_2016_22632_38178.jpg

LM Start	2.62	Rating **	M	Issue No.	21
LM End	2.62	Issue Type +	En	Location *	LS
Category	Supplemental			GPS Latitude/Longitude	
				Start	End
Item	DWR UCIP Field Study			39.030935 °	39.030935 °
				-121.823022 °	-121.823022 °
DWR ID					
Comment Code					
Inspector Comment					
FS_ID:22632					
DS_ID:22492					
EP_NO: 10012					
Repair Type: Non-Urgent					
Crossing Status: Found					
UCIP Comments: - abandoned pumphouse on landside toe. Needs confirmation from LMA or DWR Inspector about abandonment of pumphouse.- headwall on channel bank.					
FIELD_STRUCT_DESC: 24-inch steel pipe through levee, 24 feet below crown. Slide gate on waterward shoulder. Abandoned pumphouse at landward slope. (ABO No. 10012-Harris)					
FS Date: 10/10/2013

WS view: gate valve handle (center) on levee slope.

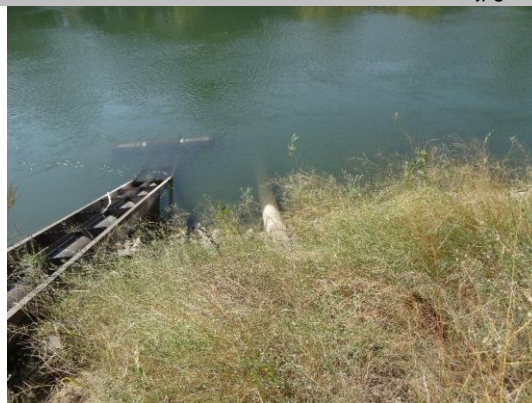
Photo 2 of 2 : UCIP_FA_2016_22632_38177.jpg

WS view: inlet steel pipe (right) immersed into channel water.

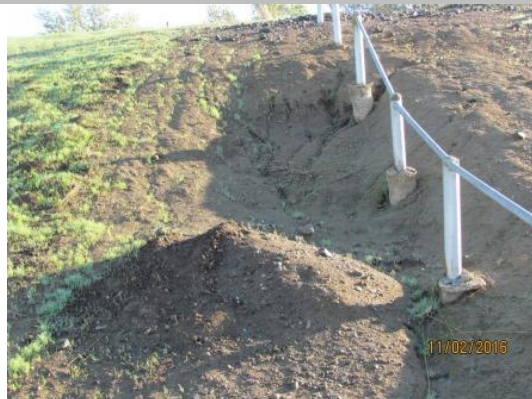
Photo 1 of 2 : FA_2016_RD1660_9_6_20161103_00006.jpg

LM Start	0.00	Rating **	M	Issue No.	6
LM End	0.00	Issue Type +	Ma	Location *	LS
Category	Earthen Levee			GPS Latitude/Longitude	
				Start	End
Item	Slope Stability			39.032910 °	39.032910 °
				-121.743665 °	-121.743665 °
DWR ID	DWR_RD1660_02_f_2016_6				
Comment Code					
S1 : Repair slope instability.					
Inspector Comment

View of the slope instability looking from the landside toe.

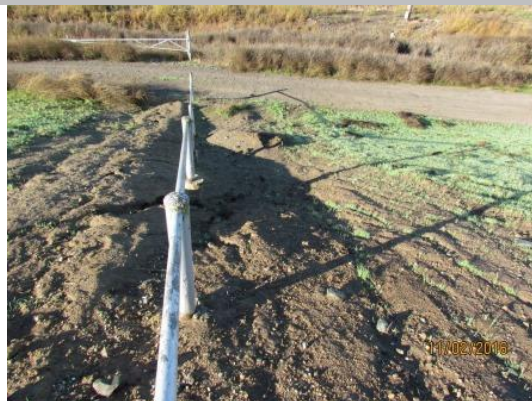
Photo 2 of 2 : FA_2016_RD1660_9_6_20161103_00007.jpg

Another view of the slope instability looking from the levee crown.

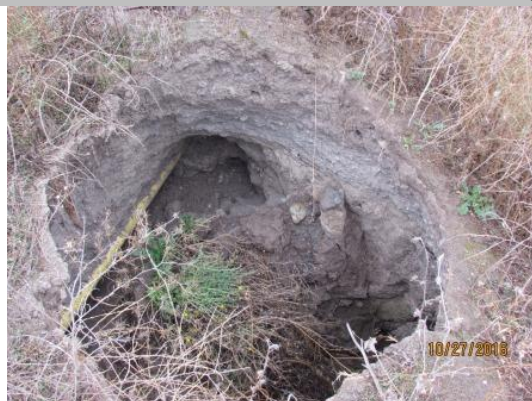
Photo 1 of 2 : FA_2016_RD1660_9_8_20161103_00008.jpg

LM Start	0.04	Rating **	A/W	Issue No.	8
LM End	0.04	Issue Type +	Ma	Location *	LS
Category	Earthen Levee			GPS Latitude/Longitude	
				Start	End
Item	Slope Stability			39.033502 °	39.033502 °
				-121.743665 °	-121.743665 °
DWR ID	DWR_RD1660_02_f_2016_8				
Comment Code					
Inspector Comment

View of a beaver hole along the toe road outside of the levee easement.

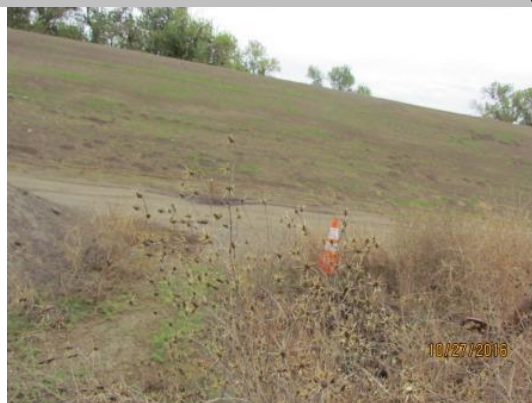
Photo 2 of 2 : FA_2016_RD1660_9_8_20161103_00009.jpg

View of the levee from the landside toe. Beaver hole is where the reflective traffic cone is.

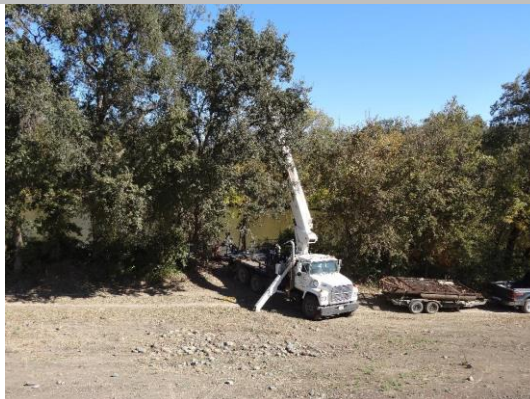
Photo 1 of 2 : UCIP_FA_2016_22705_38394.jpg

LM Start	5.10	Rating **	M	Issue No.	9
LM End	5.10	Issue Type +	En	Location *	WS
Category	Supplemental			GPS Latitude/Longitude	
				Start	End
Item	DWR UCIP Field Study			39.102512 °	39.102512 °
				-121.774960 °	-121.774960 °
DWR ID					
Comment Code					
Inspector Comment					
FS_ID:22705 DS_ID:22499 EP_NO: N/A Repair Type: Non-Urgent Crossing Status: Found UCIP Comments: Pressure relief valve on landside levee slope.Pump platform under construction for upgrade (raising platform)Look for new upgrade/revision permit. FIELD_STRUCT_DESC: 18-inch steel pipe through the levee, 5.8 feet below crown. Pump in channel. Gate valve on the landward berm. Discharges into 4-foot by 4 foot concrete box on the landward berm. 2-inch electric conduit through the levee, 3.0 feet below the crown. (Permit No. 4215, 1963) FS Date: 10/15/2013

WS view: pump platform under construction.

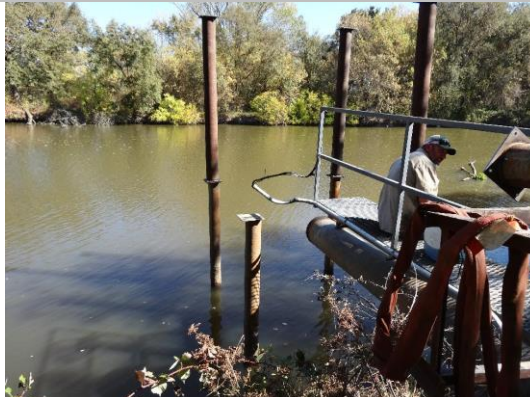
Photo 2 of 2 : UCIP_FA_2016_22705_38393.jpg

WS view: pump platform under construction. 18" steel pipe and 2" electric conduit under steel platform.

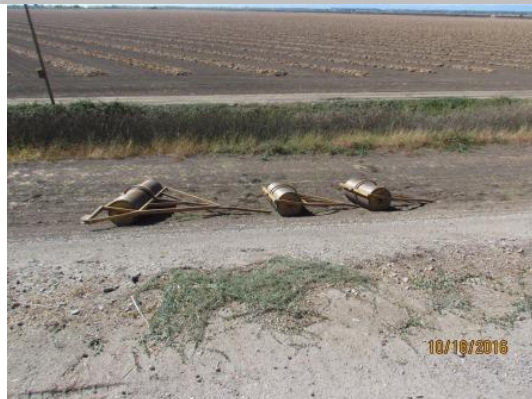
Photo 1 of 1 : FA_2016_RD1660_9_5_20161028_00005.jpg

LM Start	7.83	Rating **	M	Issue No.	5
LM End	7.83	Issue Type +	En	Location *	LS
Category	Earthen Levee			GPS Latitude/Longitude	
				Start	End
Item	Encroachments			39.126448 °	39.126448 °
				-121.815242 °	-121.815242 °
DWR ID	DWR_RD1660_02_f_2016_5				
Comment Code					
EQ : Equipment					
Inspector Comment

View of the ag equipment within the levee easement.
